ST MARY'S CHURCH HOUSE HALL

FIRE RISK ASSESSMENT

DATE: 01/05/21

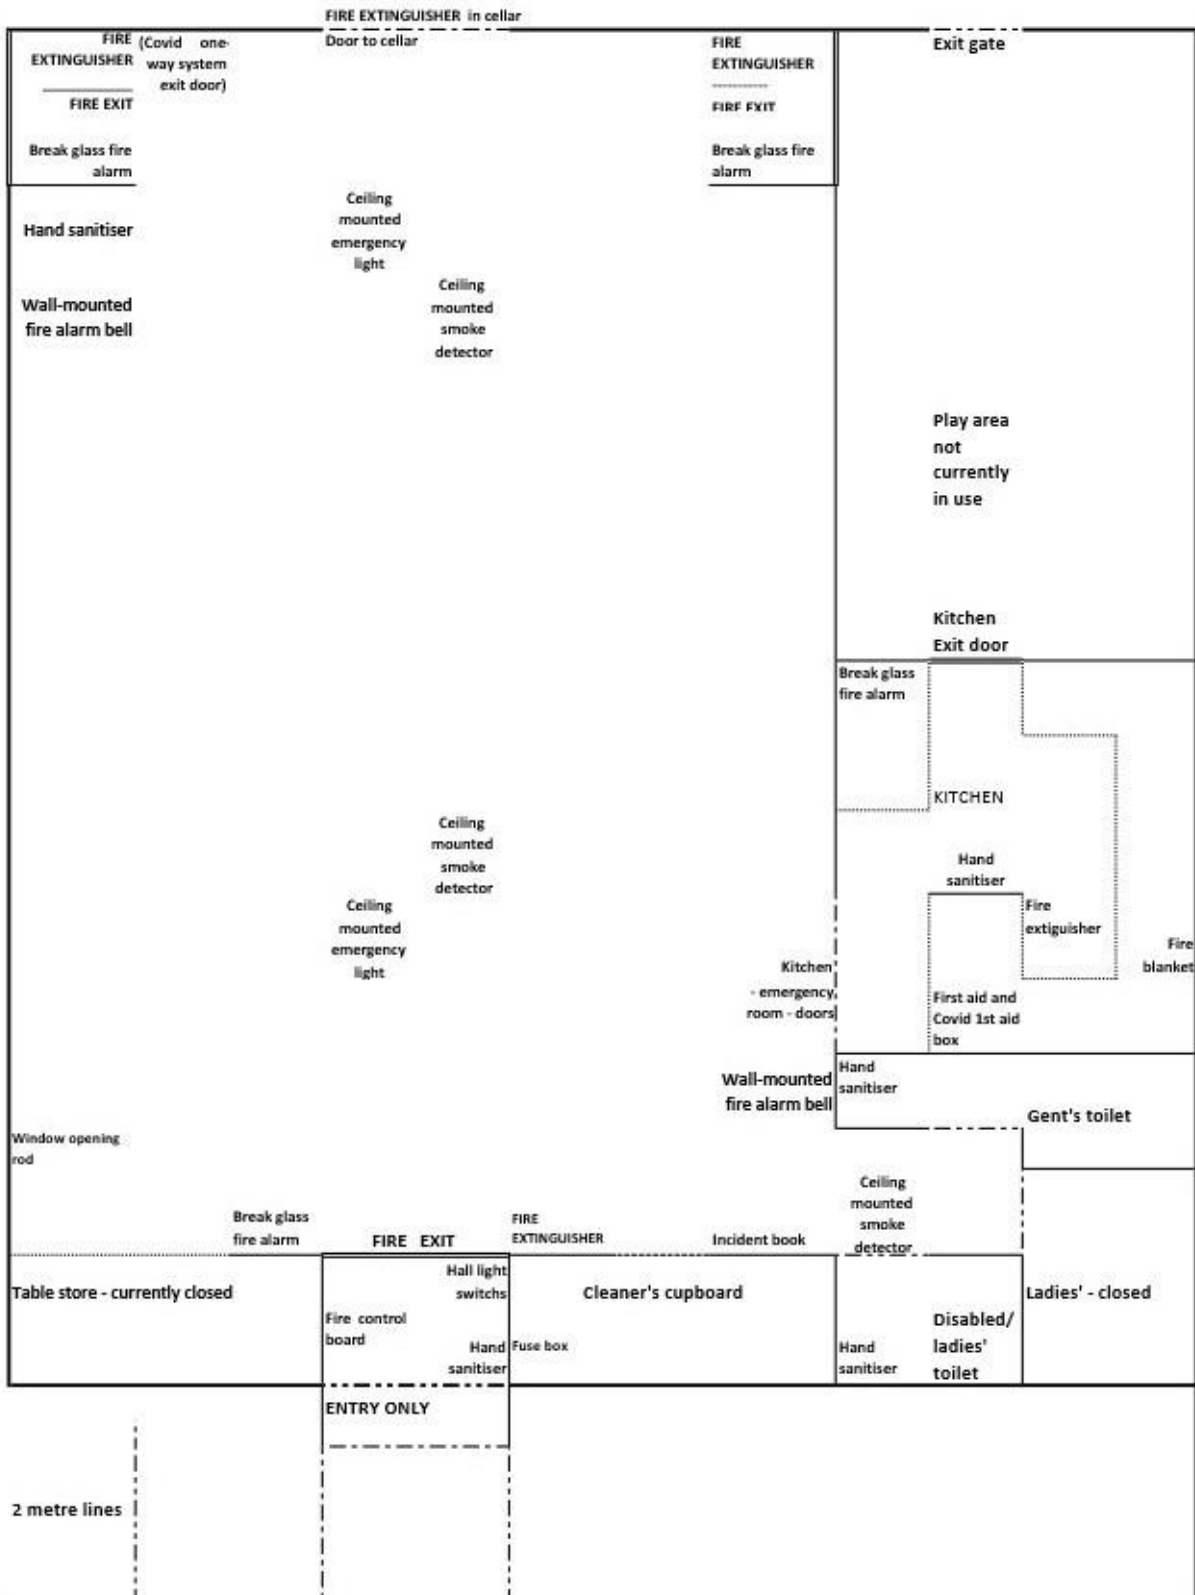
For illustration only - not to scale

There are three (water) fire extinguishers in the main hall (by entrance door and each fire exit door) and in the kitchen there is a powder extinguisher on a wall facing the cooker and fire blanket adjacent to the cooker, as indicated on the accompanying plan. These are inspected annually by an external contractor, and the certificate of inspection is in the Health, Safety & Compliance file on a shelf in the kitchen facing the doors. Visual inspection of extinguishers is also undertaken regularly by the caretaker.

Escape routes are all unencumbered and are shown on the attached plan and listed in the accompanying table. All external doors lead to the outside and thence to the adjacent footpath and churchyard which provide an open space for safe and easy evacuation of the hall. **The Fire Assembly Point following evacuation of the hall is on the South Street pavement adjacent to St Mary's Church.**

Escape routes and exits together with the locations of firefighting equipment are indicated by appropriate signs throughout the building, as indicated on the attached plan and in the accompanying table. Fire exit signs are included on emergency lighting panels throughout the hall. Fire extinguishers have clearly displayed operating instructions on them.
